### Inspection Report

Date of Inspection 12/31/2010

**Premier Home Inspection, LLC**

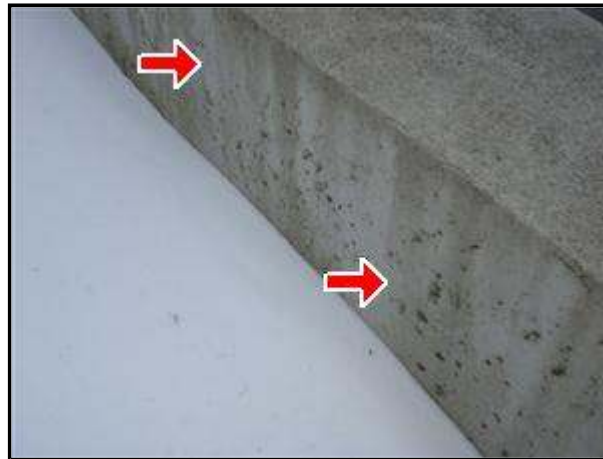
1.0 Picture 1 Foundation

The foundation is a poured concrete and where visible and accessible seems to be in good condition for its age. No major structural cracks were noted at the time of inspection. Most of the foundation is covered with stone, so inspection was greatly restricted.

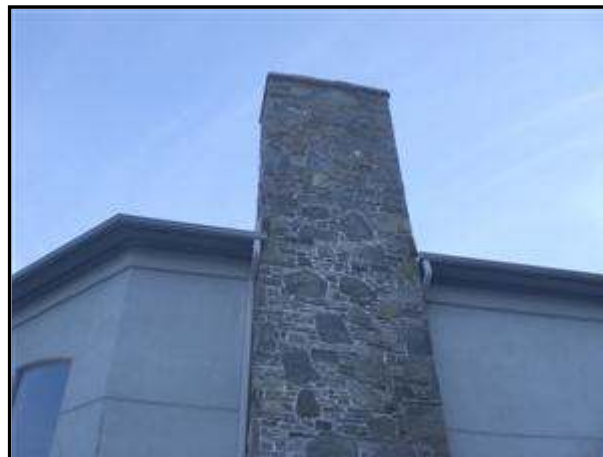
1.1 Picture 1 Chimney

(1) The chimney is located on the right side of the house (as seen when facing the front of the home).

Condition of the chimney appears that no immediate need for major repairs are required. Such as repointing.

The chimney is tight to the home and no major cracking was noted.

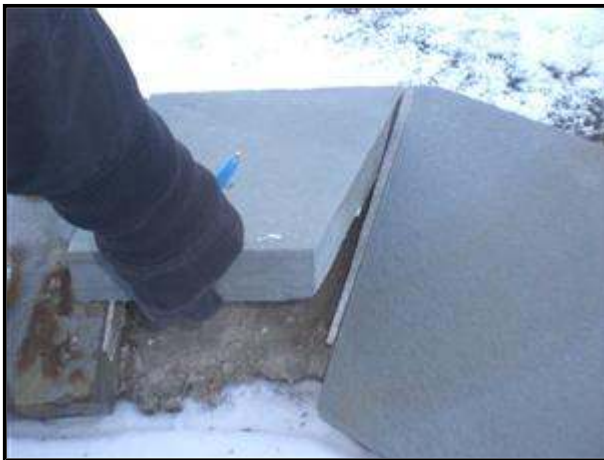
1.5 Picture 1 Front retaining wall cap loose

The retaining wall in the front of the house has a stone cover cap that is loose. Recommend having this secured.

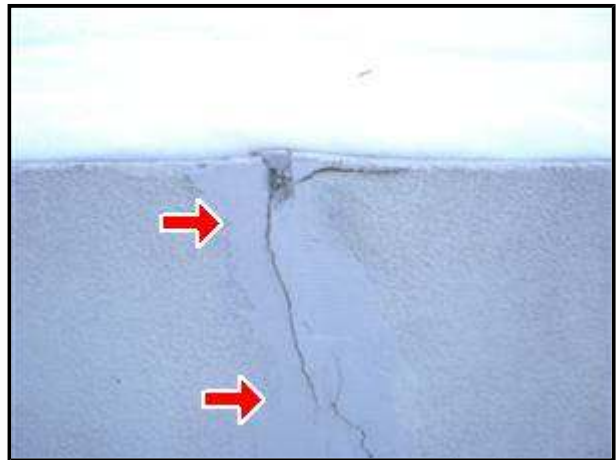
1.5 Picture 2 Rear retaining wall crack in stucco

The rear retaining wall has a crack in the stucco covering. I was able to determine that the wall is poured concrete. Recommend having this crack in the stucco repaired to prevent anymore additional damage.

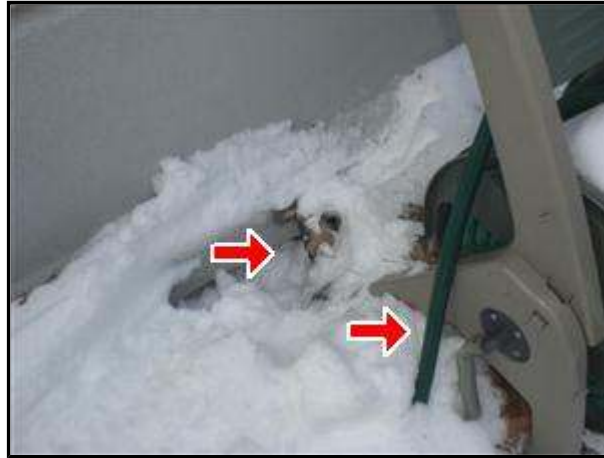
1.8 Picture 1 Frozen hose

The hose faucets were tested and water flowed from them. The exception being one at the rear of the house. This was most likely caused by the fact that the hose attached was frozen solid. They should be turned off as cold temperatures could cause freezing pipes.

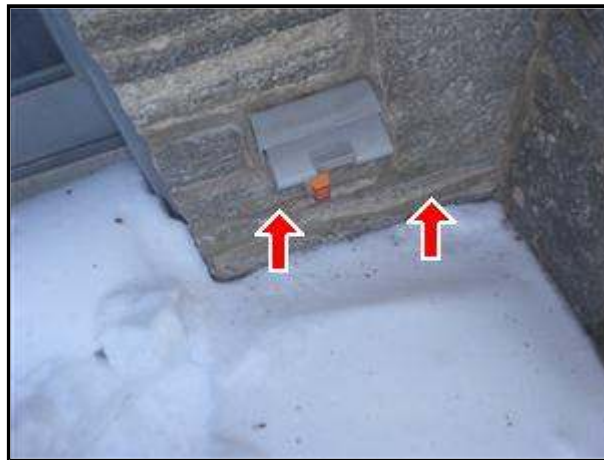
1.9 Picture 1 No power to outlet

The outlets on the exterior of the house are GFCI and they were tested and all were functional at the time of the inspection. The exception being one on the left front of the house. Recommend having a certified electrician make necessary repairs.

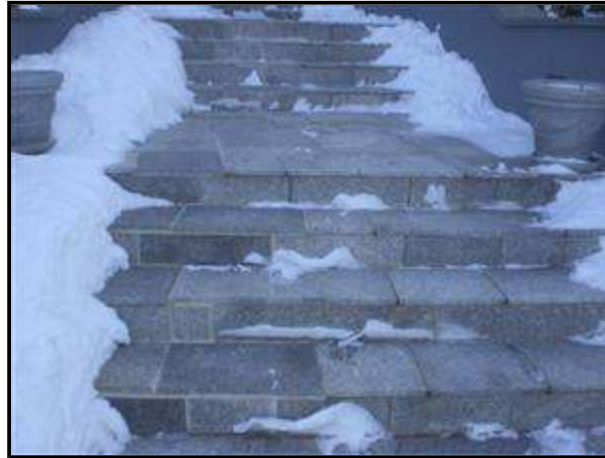
1.11 Picture 1 Front Walkway

The front walkway seems to be stone and is in good condition. I did not note any major cracking or depressions.

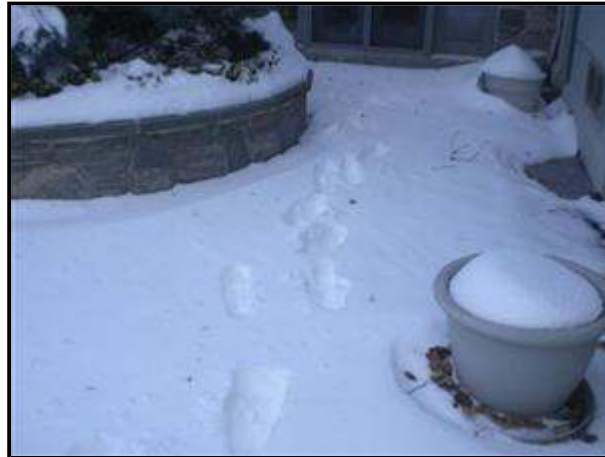
1.12 Picture 1 Snow cover patio

There is a stone patio at the rear of the house. Inspection was extremely limited due to snow cover.

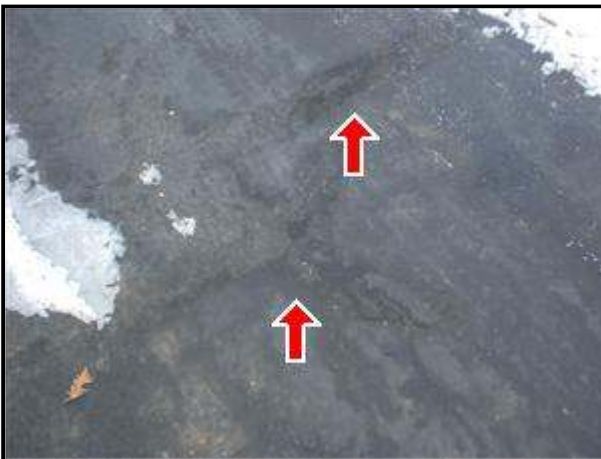
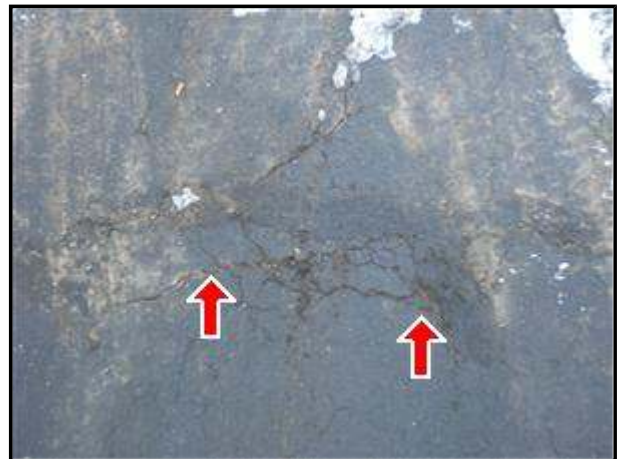
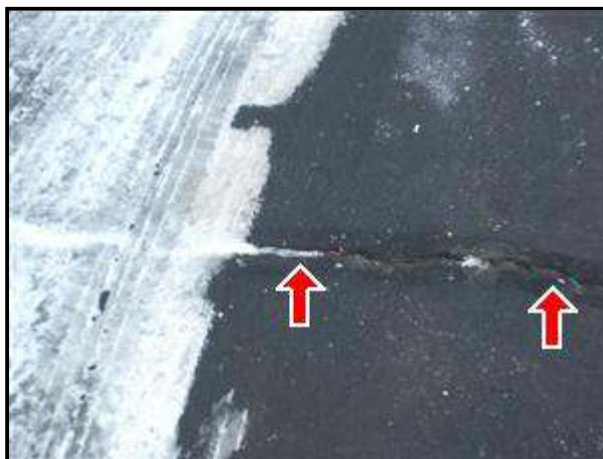
1.13 Picture 1 Driveway cracking

1.13 Picture 2 More Driveway cracking

1.13 Picture 3 Driveway Cracking

The driveway for the most part is in good condition. There is minor cracking in several sections noted and that should be sealed to prevent anymore damage. Recommend having a certified paving contractor evaluate and make necessary repairs.

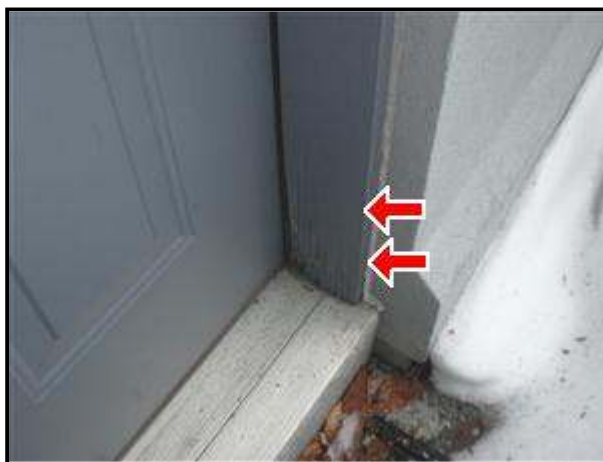
1.15 Picture 1 Rear door framing rotting

The rear door appears to be functional at the time of the inspection. I opened it and it did close properly. The rear door off the garage at the back of the house has a section that has some rot at the base of the frame. Recommend repair of rotting frame.

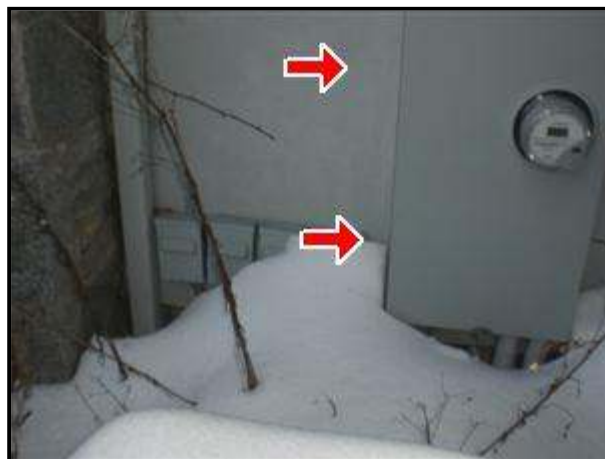
1.17 Picture 1 Electrical Service Entry

The electrical service entry is below ground and could not be inspected.

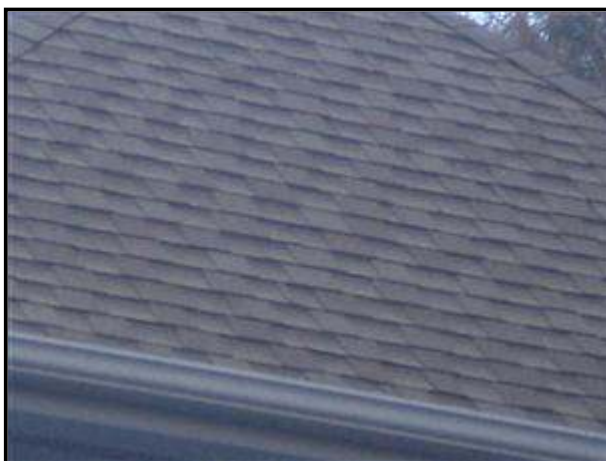
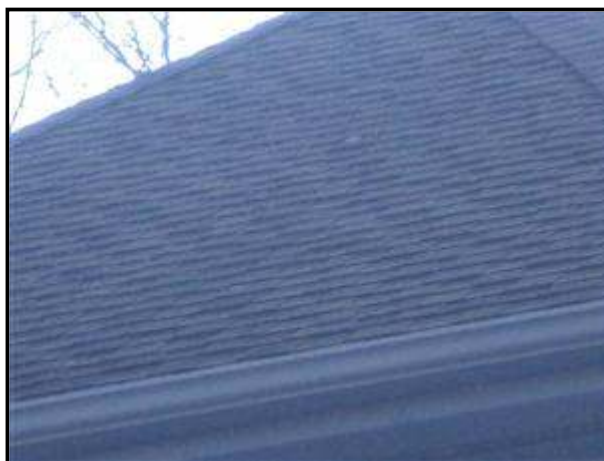
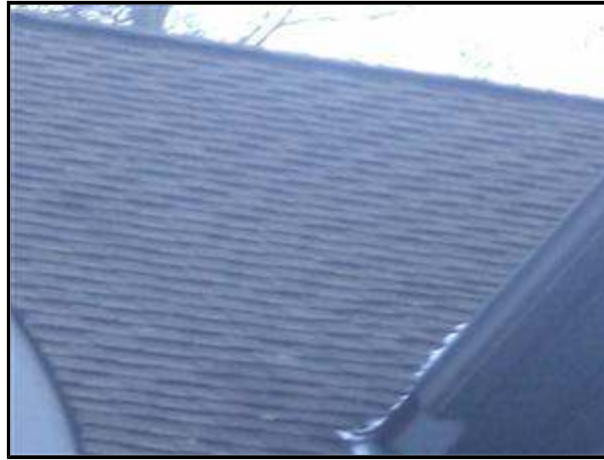
The roof is performing its intended function at the time of the inspection. The roof lines were straight and the shingles did not show any signs of lifting, cupping or substantial particulate loss. This architectural shingle has a life expectancy of 18-25 years. As house was built in 1996, I would place this roof statistically at midlife.

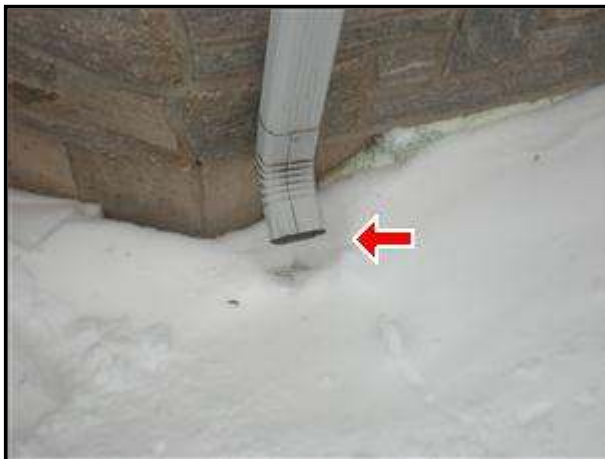
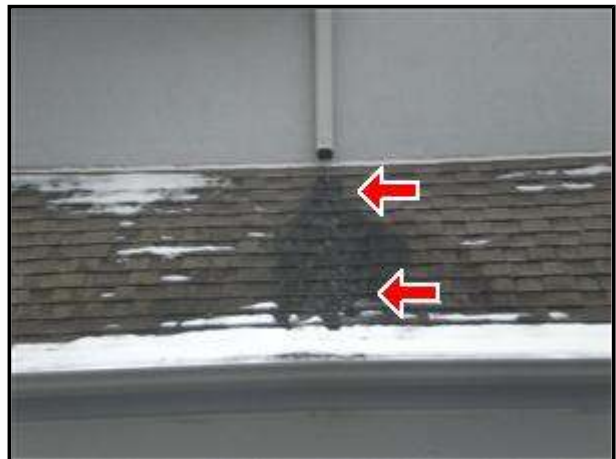
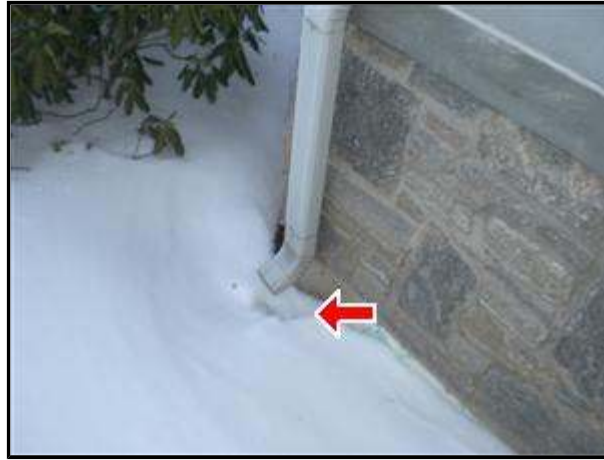
2.6 Picture 1 Missing gutter Extension

2.6 Picture 2 Gutter Extension recommended

2.6 Picture 3 Missing extension

The gutters were viewed from the ground so it could not be determined if there was debris in the gutters. There were no leaks at the time of the inspection. The downspouts in several sections were missing extensions at the bottom and it is recommended that new ones be placed to move water away from the house.

In two or three areas of the roof gutter extensions are recommended to prevent possible damage to the roof covering.

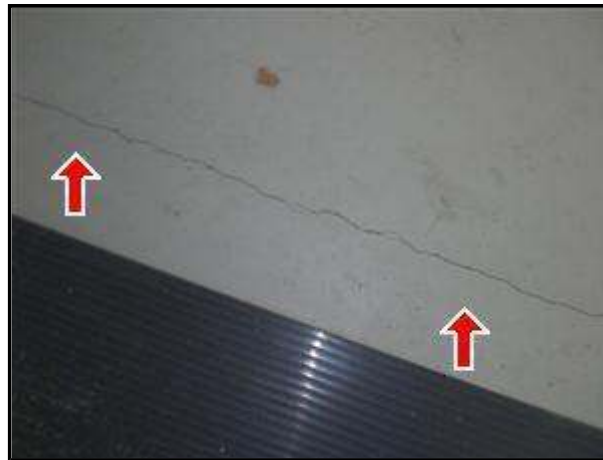
3.1 Picture 1 Garage Floor

There are several concrete 'shrinkage cracks' noted in the garage. These common cracks are cosmetic only and are not indicative of any significant issues at this time.

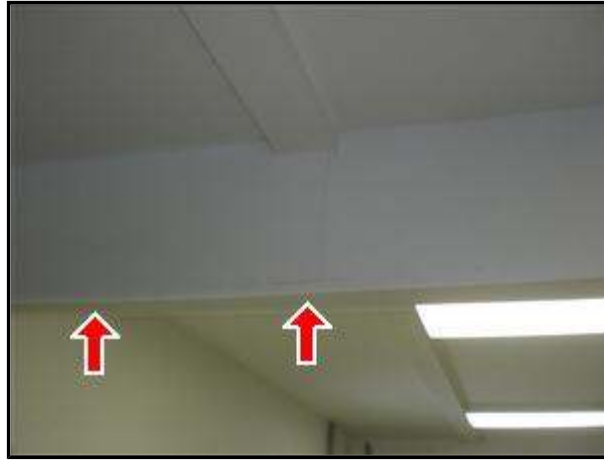
3.2 Picture 1 Drywall cracking

The garage walls were completely enclosed with drywall. Access was limited due to storage in one area of the garage. The walls where visible seemed in good condition. The exception being the ceiling where there are several minor cracks in the drywall.

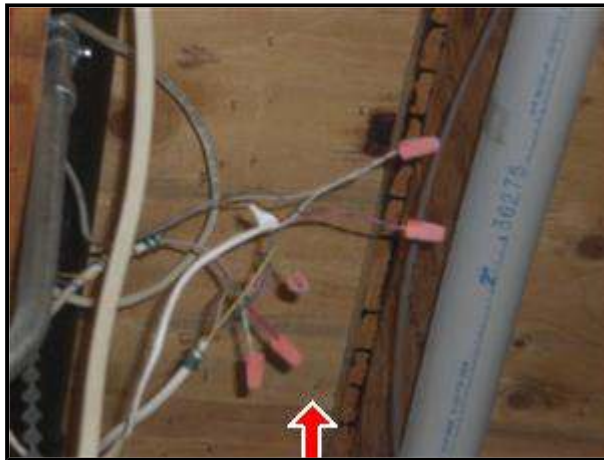
There are also some exposed wires in the utility room. Recommend having a junction box installed to enclose wires.

Basement utility room exposed wires

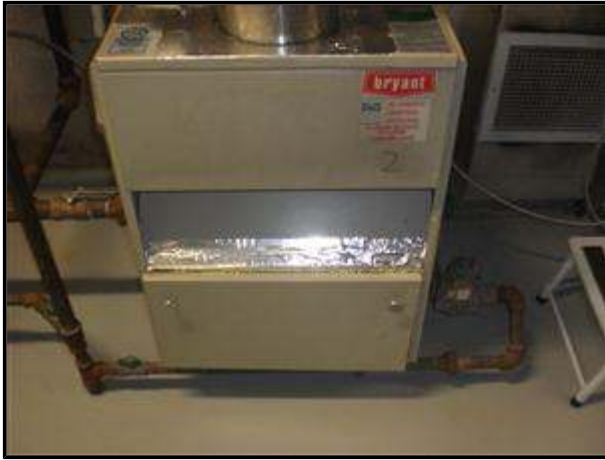
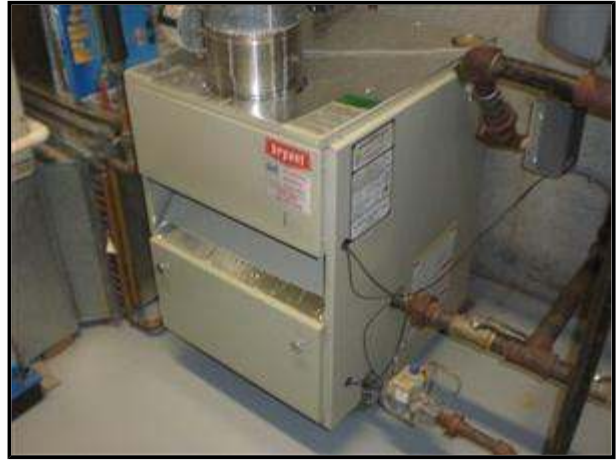
(1) There is a five-zone hydro system in the house. Two Bryant gas fired boilers supply the system. I did fire the units and they did heat the house accordingly. The units did not make any unusual noises. I did not note any leaking from the units at the time of the inspection. They appeared dry and clean. The life expectancy of this type of unit is anywhere from 20 - 30 years. The units functioned normally at the time of the inspection, I would place these units at the middle of their life expectancy.

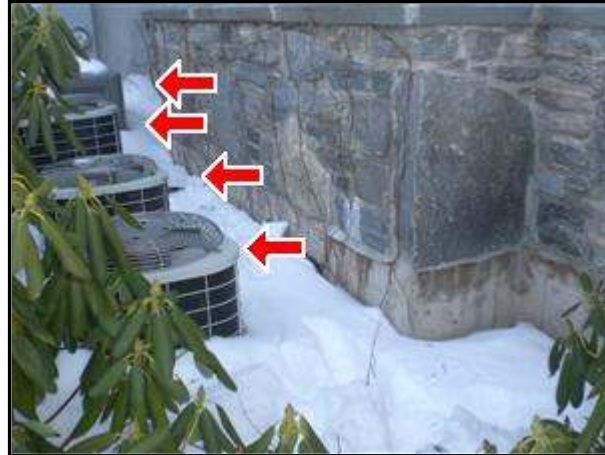
5.6 Picture 1 Air Compressors

(1) The Allegiance AC compressor did show a manufacturing date of 2005. The life expectancy of an AC compressor is 12 years. I would place this unit at the beginning of its expected life cycle. The three other compressors do not show the name of the manufacturer or the date they were manufactured. I would say from a visual inspection that these units are original to the house and past their expected life cycle. This is not to say that when they are run they will not function properly.

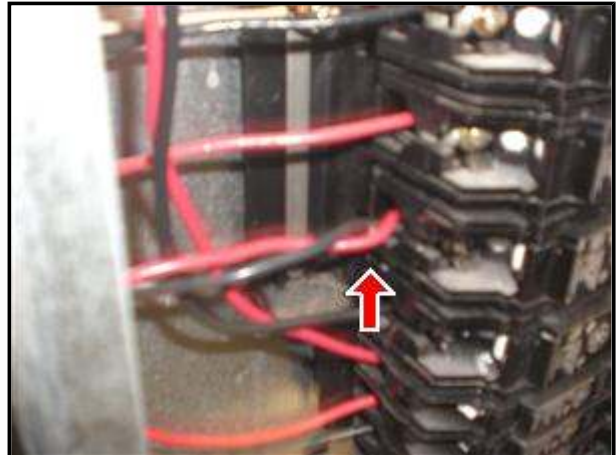
6.1 Picture 4 Double Tap

There are two main panels. The main disconnect breakers read 200 amps on each. The interior of the boxes looked clean and free of rust or corrosion. I noted what appeared to be aluminum wiring coming into the home from the street. The branch wiring looked to be copper. The branch wires did look proportionally sized to their amperage. There was no corrosion noted on any of the wiring. There also appears not to be any double tapping. The exception being one double tap on the box to the left. Recommend having a licensed electrician make necessary repairs.

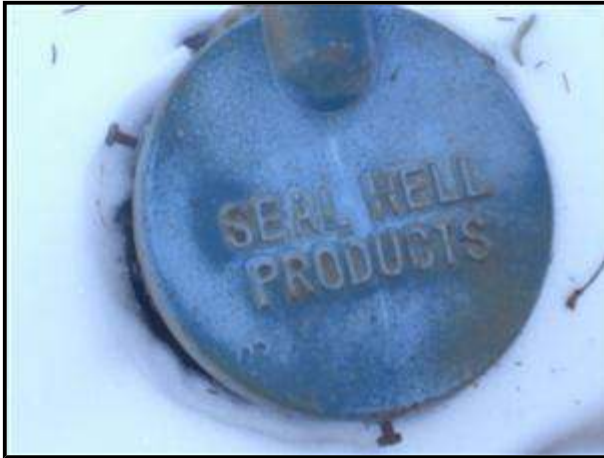
7.0 Picture 1 well head

Water appears to be supplied by a well. I strongly recommend having the well evaluated by a certified water company as a well flow test was performed and there results were not what I normally see. Please see attached well flow test form.

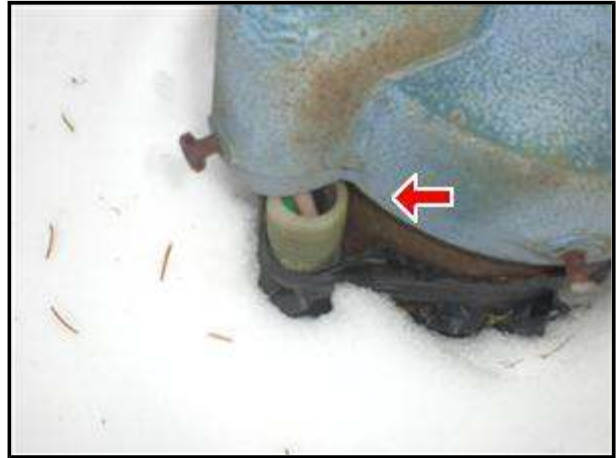
7.0 Picture 2 well head wiring open to elements

The well head also has a section that protects the wiring from the elements. The wiring is currently exposed so I recommend correcting this issue.

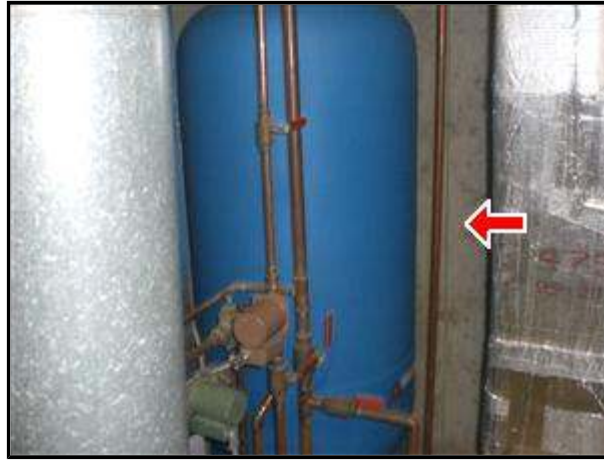
7.5 Picture 1 water storage tank

At the time of the inspection the water storage tank appears to be in good condition with no signs of leaks or physical damage. The estimated life cycle is approximately 12-15 years. This unit looked in newer condition. I was unable to determine a date of manufacturing. I am placing this unit approaching the end of its expected life cycle, although, at the time of the inspection the unit is performing its intended function of supplying domestic hot water.

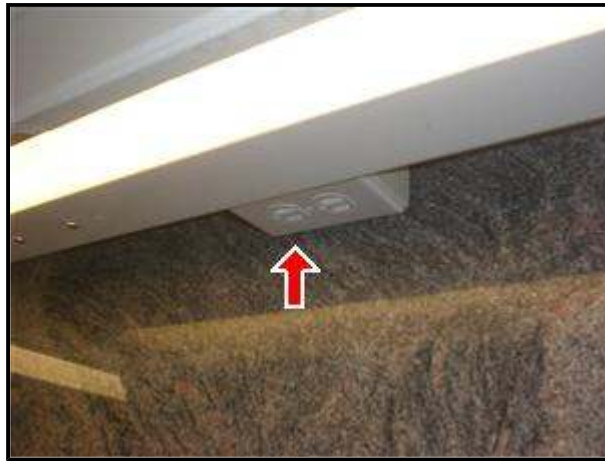
**There is a section of the kitchen that has under cabinet lighting. Also located under the cabinets, are kitchen outlets. None of these outlets are GFI. Recommend having an electrical contractor make upgrades as necessary.**

Kitchen outlet not GFI

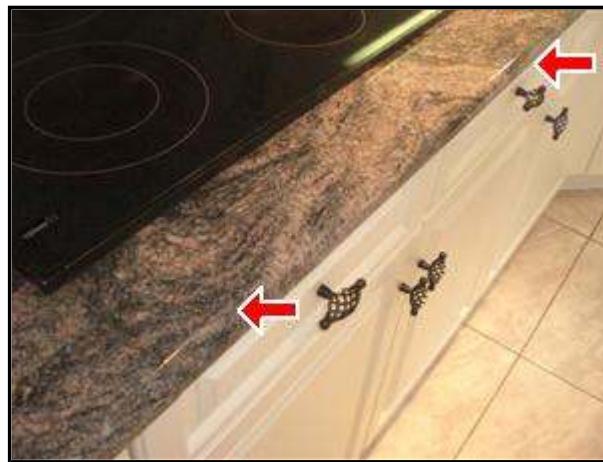
8.1 Picture 1 Loose Counter top

Counter tops seem secure and there appear to be no major defects. The exception being a section of the granite in front of the stove top that is loose. Recommend having this secured.

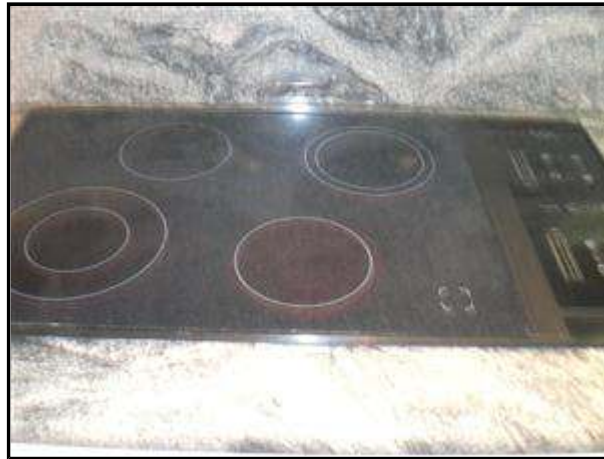
8.9 Picture 1 Stove top not functioning

Appears to function properly, the range did heat up and all cook top burners heated up. The exception being the one stove top at the back wall. This seemed to have power but I could not get the burners to heat up. Recommend having a appliance repairman make necessary repairs.

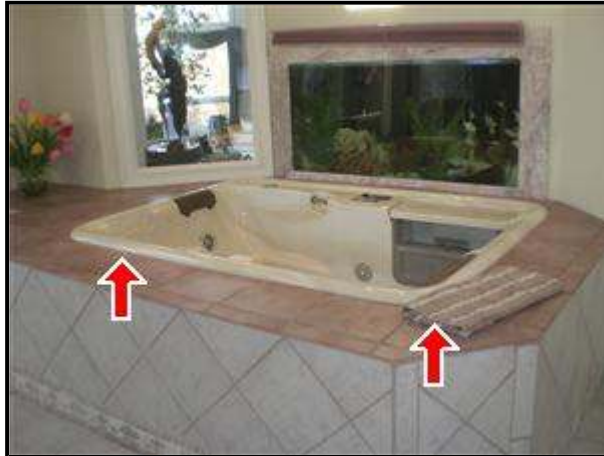
There is a hot tub on the main level which was not run during the inspection. Client informed me that he is aware of its disrepair.

Hot tub

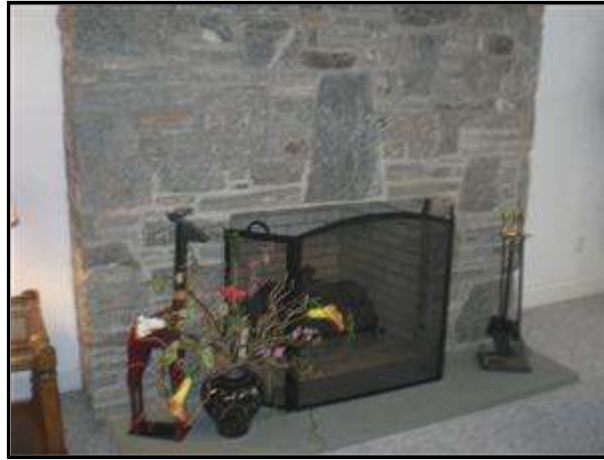
9.1 Picture 1 Fireplace

The liner on both chimneys that were able to be inspected (basement, living room) are mainly visible and appear in good condition except for creosote dust that may conceal a hairline crack which can not be determined until it is cleaned and inspected by a licensed chimney sweep. For a detailed inspection of liner, I recommend a qualified chimney sweep inspect for safety.

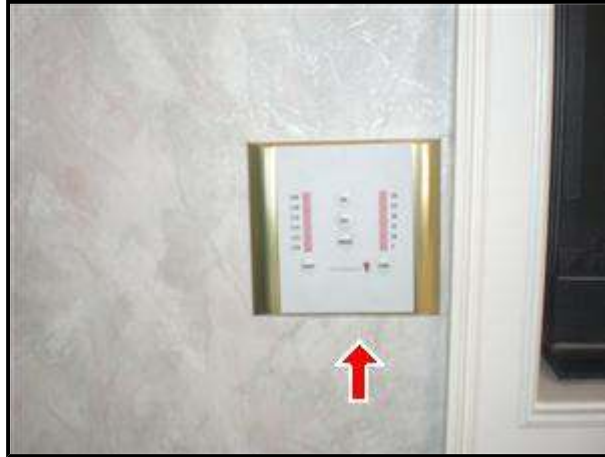
There seems to be a steam system for the master bathroom. I was unable to run the unit. Recommend asking th home owner if the unit is functional and how it works.

Steam control for master bath
